# **Pipeline Repair Using Clock Spring Composite Sleeve Reinforcement**

**Author: Scott Rukke, Washington Utilities & Transportation Commission**

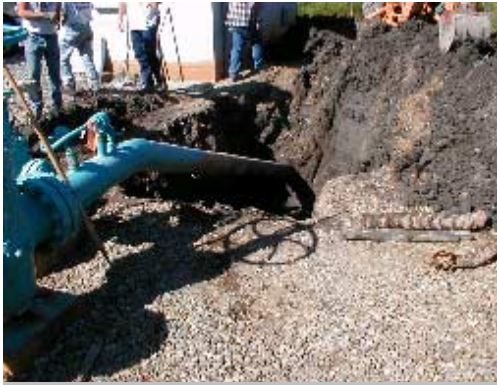
### Locating Anomaly

The general area of the anomaly (damage) is excavated based on distance from a reference point such as a valve or number of girth welds from the inspection tool launch point.

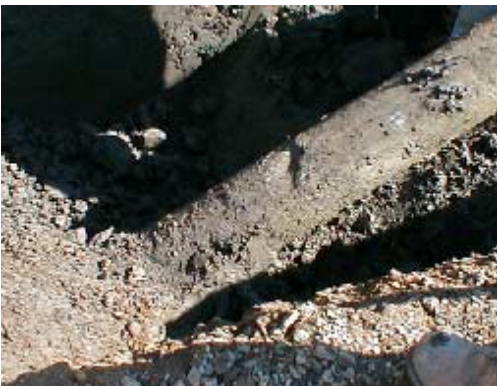
### Excavation

The pipeline is exposed, the anomaly located and a preliminary evaluation conducted.

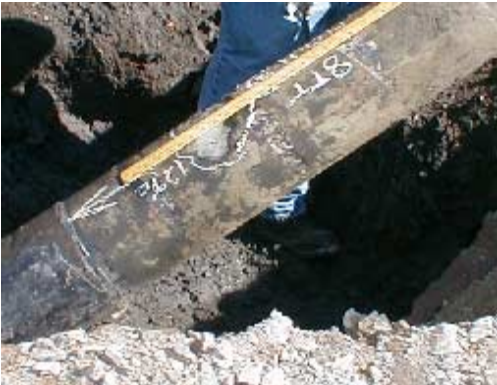
### Pinpointing Anomaly

Exact measurements are taken from a point of reference such as a girth weld. The preliminary size and orientation of the anomaly is documented.

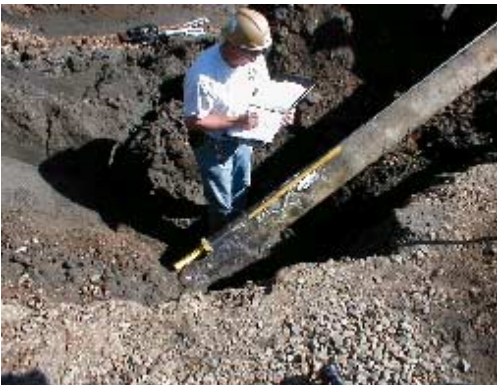
### Documenting Pipeline Condition

All information is documented prior to removal of the wrap or coating.

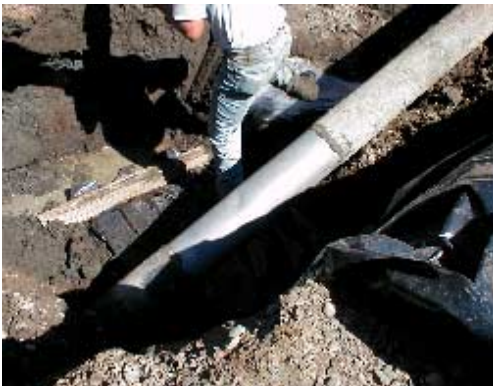
### Preparation of Pipeline For Evaluation

The sandblasted pipeline is prepared for an in depth evaluation of the anomaly.

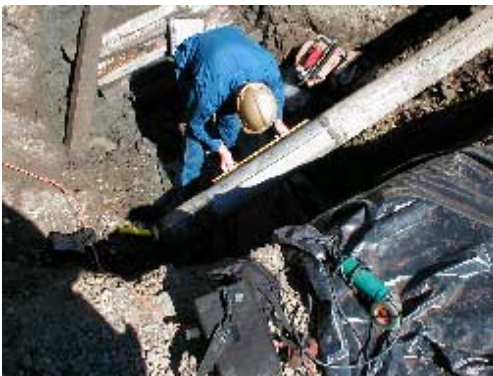
### Defect Measurement

The anomaly is measured, documented and examined for any cracks, grooves or other imperfections which could affect the strength of the pipeline.

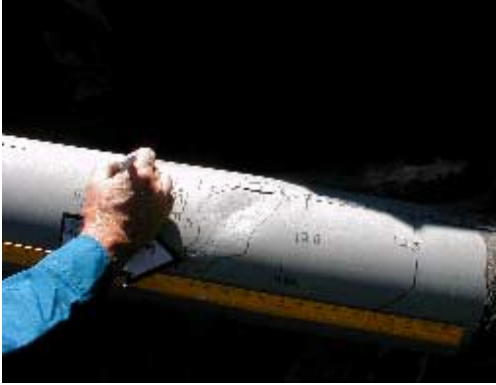
### Defect Evaluation

Precise measurements are taken of the size of the anomaly. The damaged area is also examined for any surface cracks or other strength reducing damage. The area is photographed.

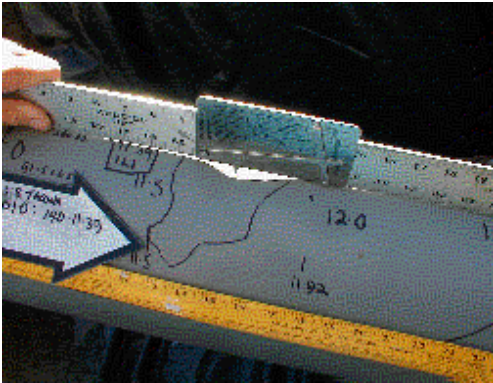
### Depth Measurement

The depth of the damage is measured and recorded. The damaged area is also photographed throughout the evaluation. The damage is evaluated using an industry recognized criteria to determine whether the damage can be repaired or must be cut out.

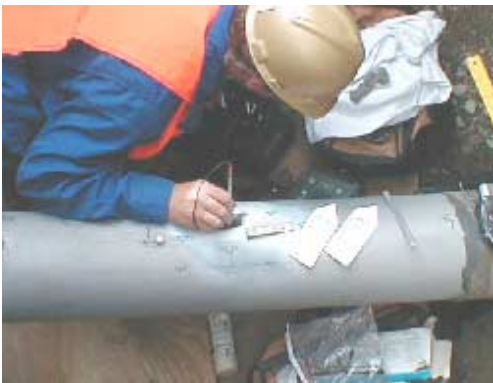
### Ultrasonic Thickness Test

Ultrasonic wall thickness measurements are taken to evaluate any apparent wall loss. The damage is evaluated using an industry recognized criteria to determine whether the damage can be repaired or must be cut out.

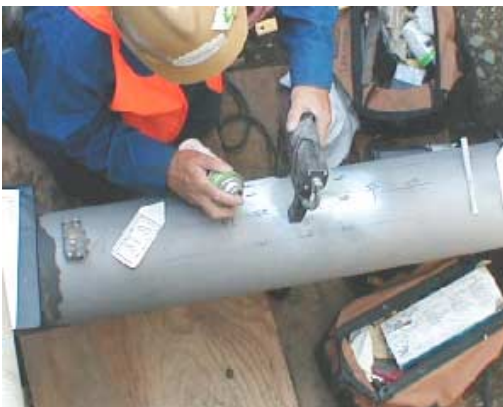
### Magnetic Flux Crack Detection

Since many surface cracks are not visible to the naked eye a magnetic flux evaluation is conducted to determine the extent of any cracks or other strength reducing imperfections in the pipeline.

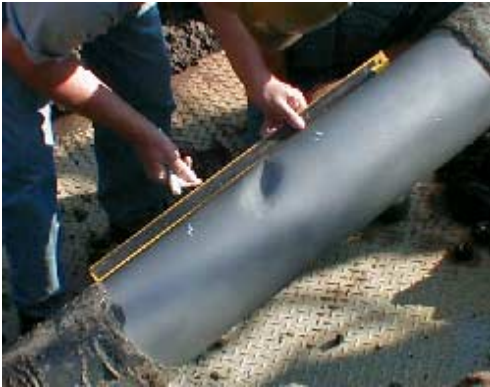
### Final Documentation and Evaluation

The anomaly is further evaluated prior to the installation of the Clock Spring repair sleeve.

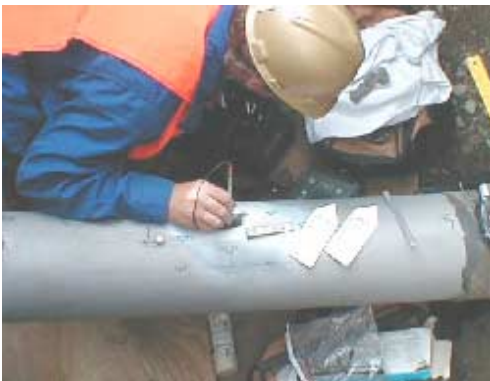
### Ultrasonic Wall Thickness Tests

Ultrasonic wall thickness measurements are again taken after grinding to measure actual remaining wall thickness prior to the installation of the Clock Spring.
